REMOVAL ACTION PLAN
DAYTON TIRE AND RUBBER COMPANY
DAYTON, OHIO

CONTRACT NO. 68-01-7367

WESTON-SPER
Technical Assistance Team
Region V

January 1988

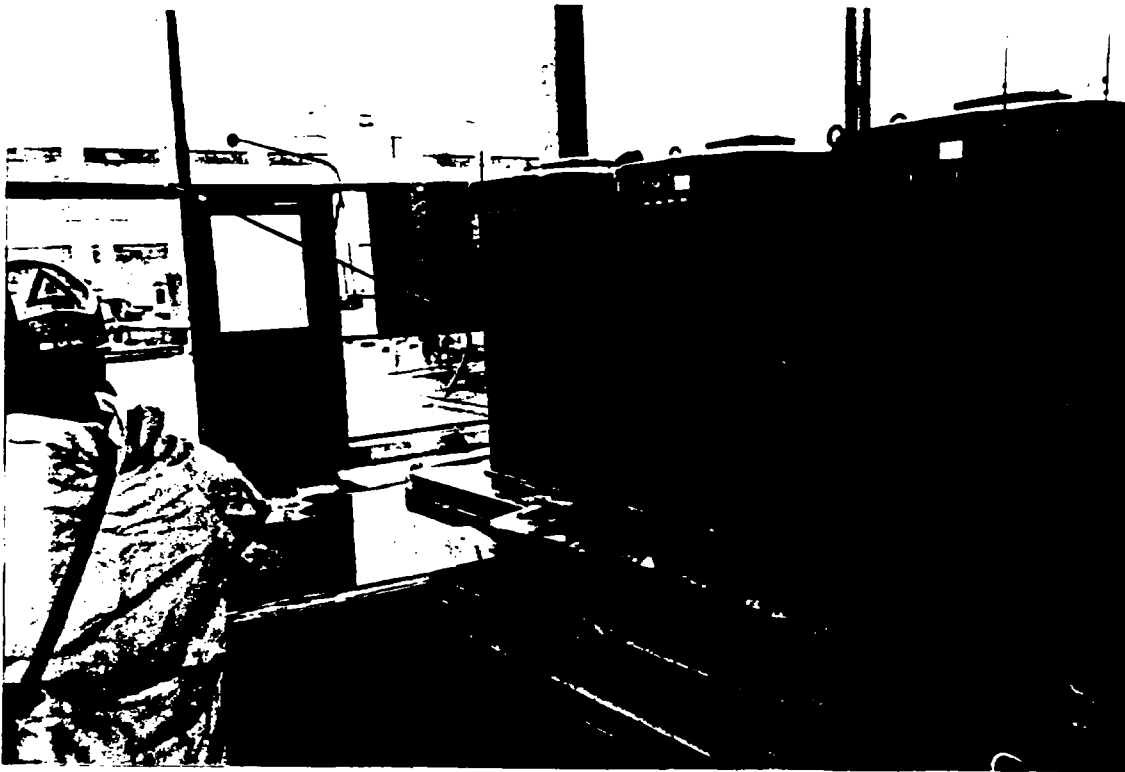
PHOTO 7: DAYTON TIRE AND RUBBER COMPANY, Dayton, OH.
Transformer Area A.

All of the oil in the four transformers remaining in this area
were pumped in to drums.

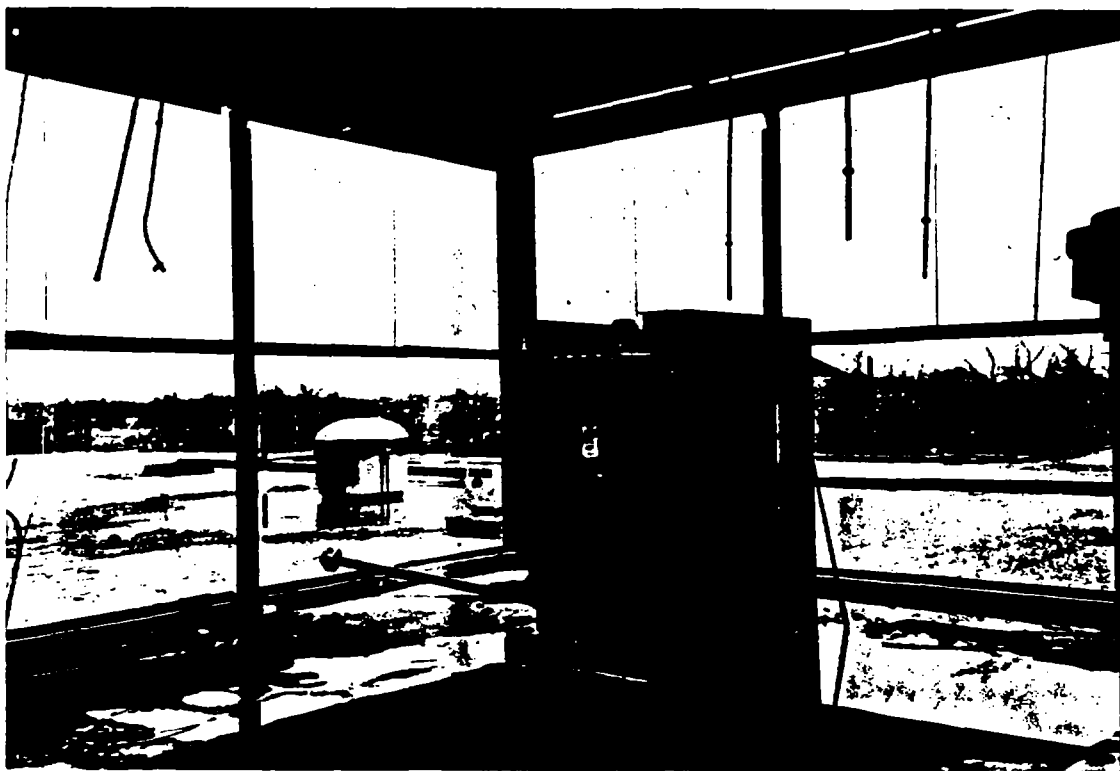
PHOTO 8: DAYTON TIRE AND RUBBER COMPANY, Dayton, OH.
Transformer Area A.

The center of the floor was open to the first floor of the
facility.

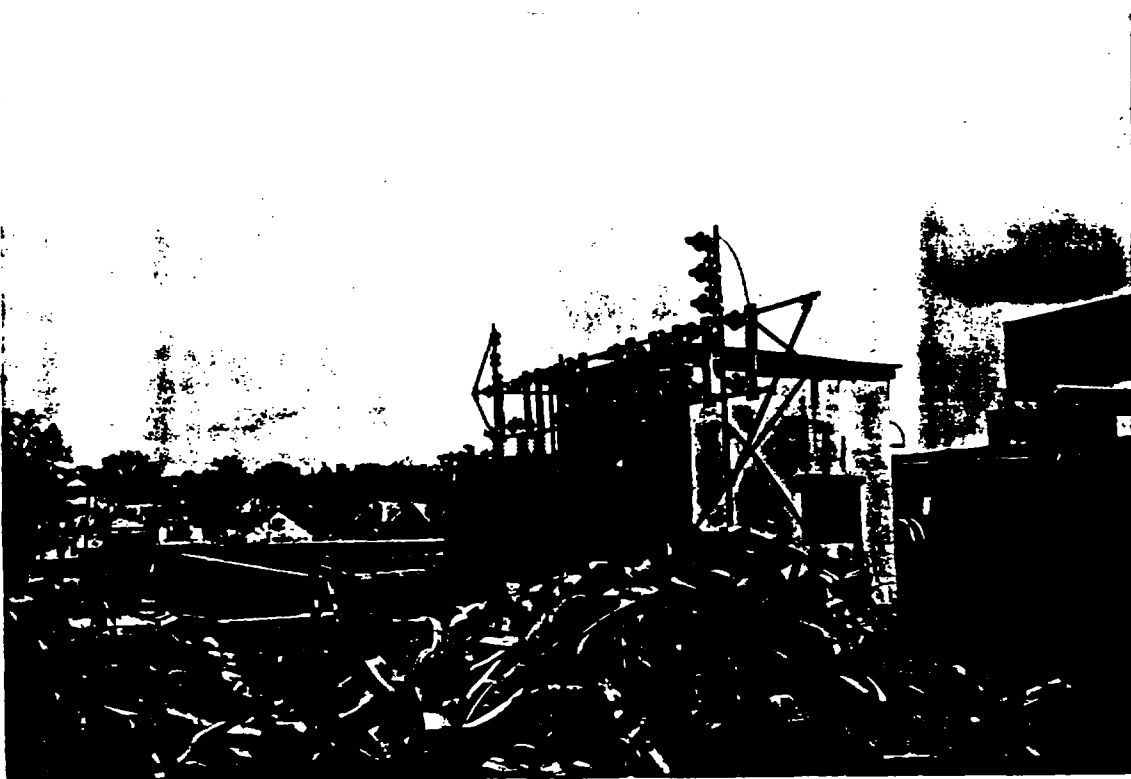
PHOTO 11: DAYTON TIRE AND RUBBER COMPANY, Dayton, OH.
Transformer Area C.

Three of the five transformers were found upright. The metal bands in the foreground from the transformers were later staged inside the building.

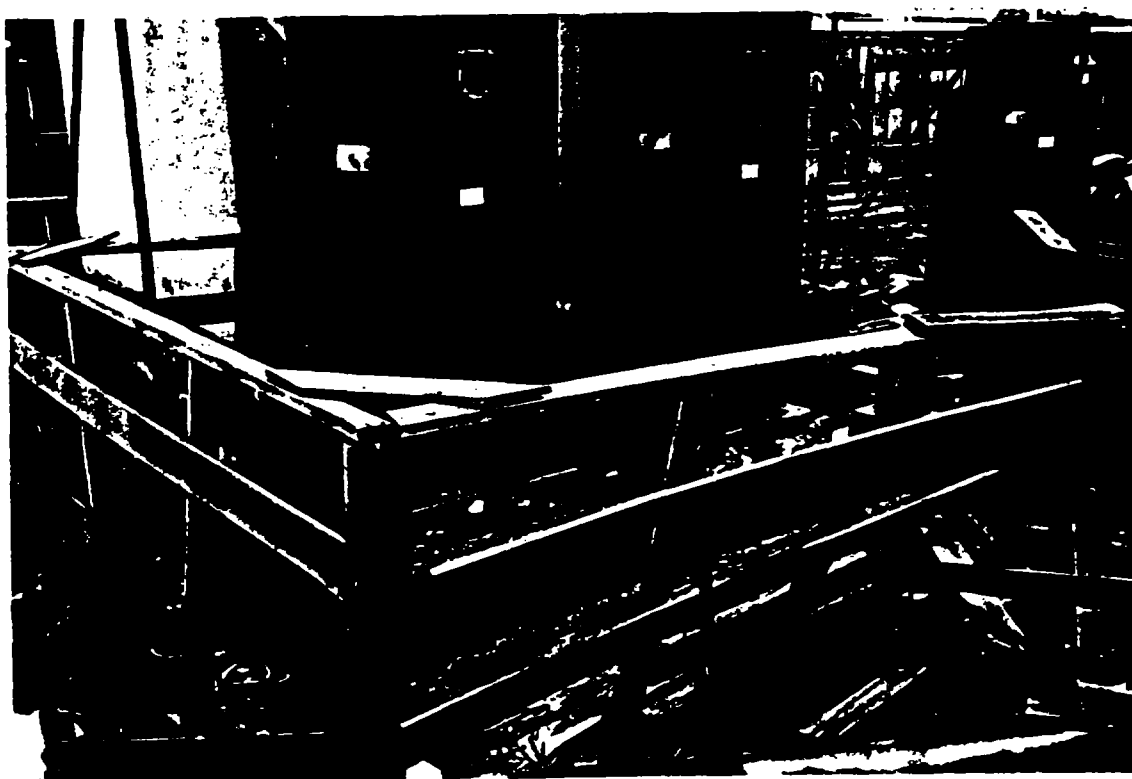
PHOTO 12: DAYTON TIRE AND RUBBER COMPANY, Dayton, OH.
Transformer Area C.

The small dike around the transformers had retained some of the PCB oil, but most had seeped through the roof and onto areas of the first floor and basement.

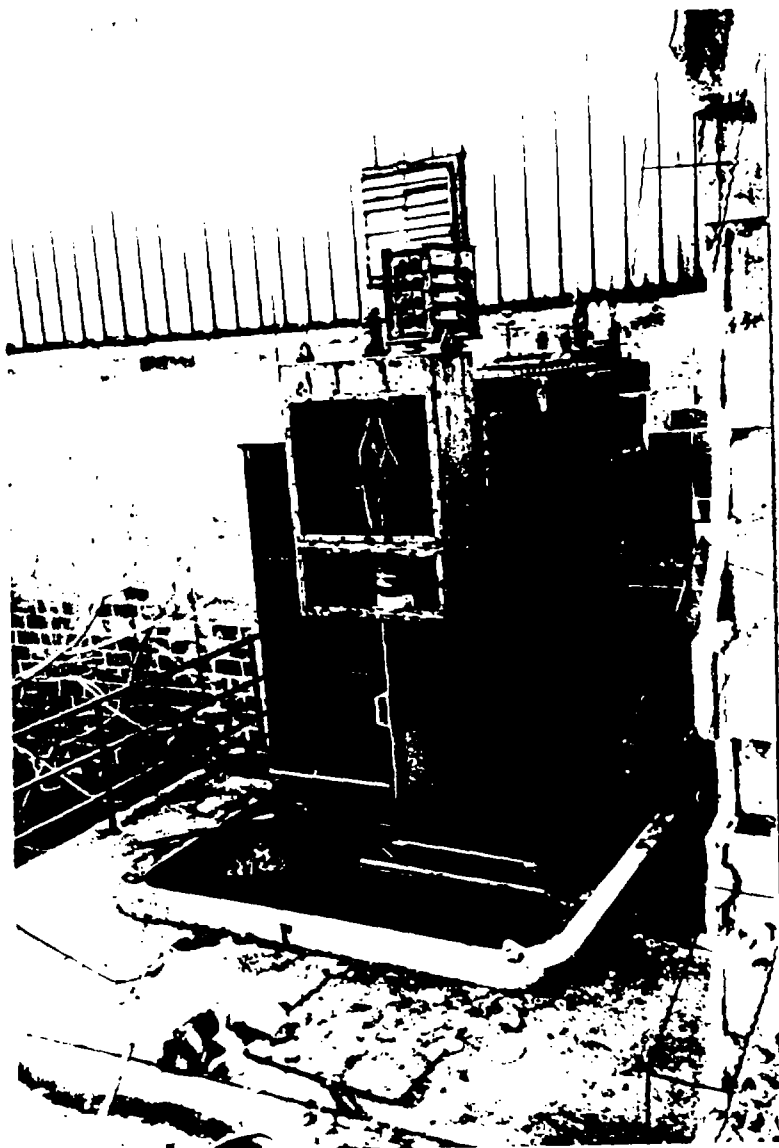
PHOTO 13: DAYTON TIRE AND
RUBBER COMPANY, Dayton, OH.
Transformer Area D.
This transformer area was on
the roof near area E.
(Photo by Scoville, 4/7/87,
1730 hrs.) *WLB*

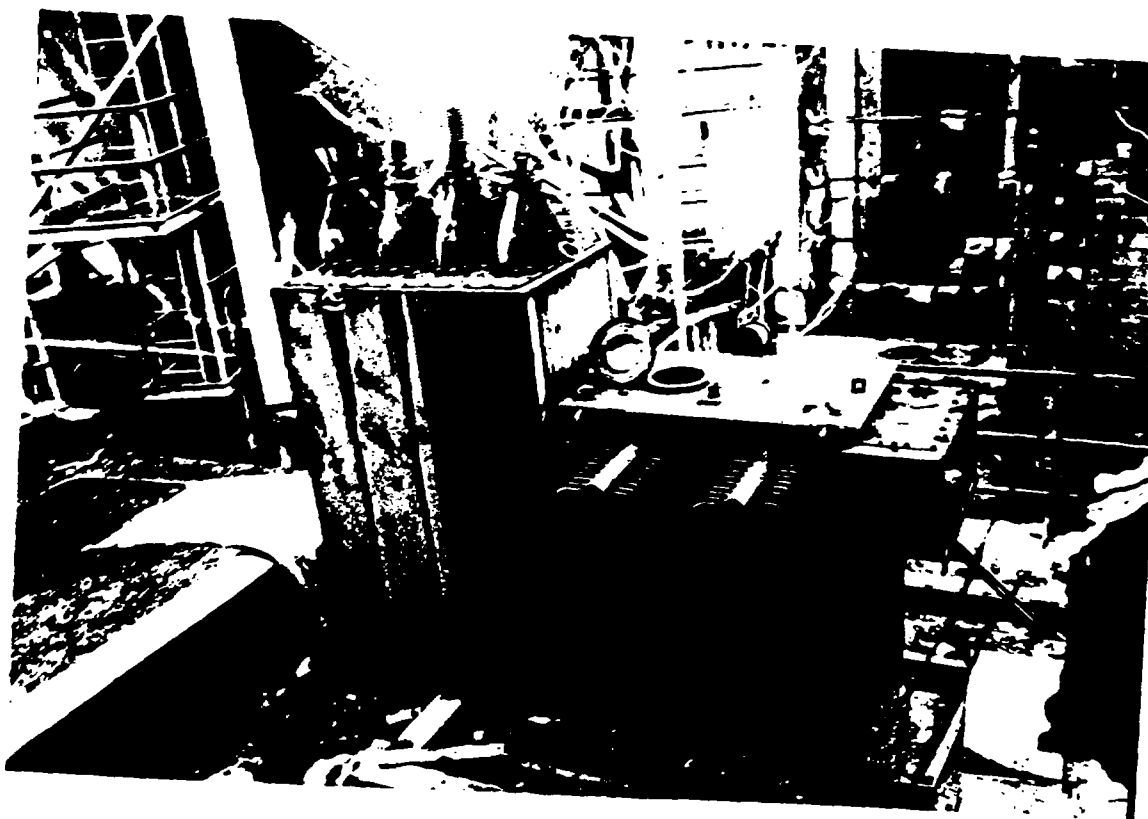
PHOTO 14: DAYTON TIRE AND
RUBBER COMPANY, Dayton, OH.
Transformer Area D.
These transformers were
covered with plastic to
prevent rain from entering the
transformers and spreading
more PCB oil.
(Photo by Scoville, 4/7/87,
1730 hrs.) *WLB*

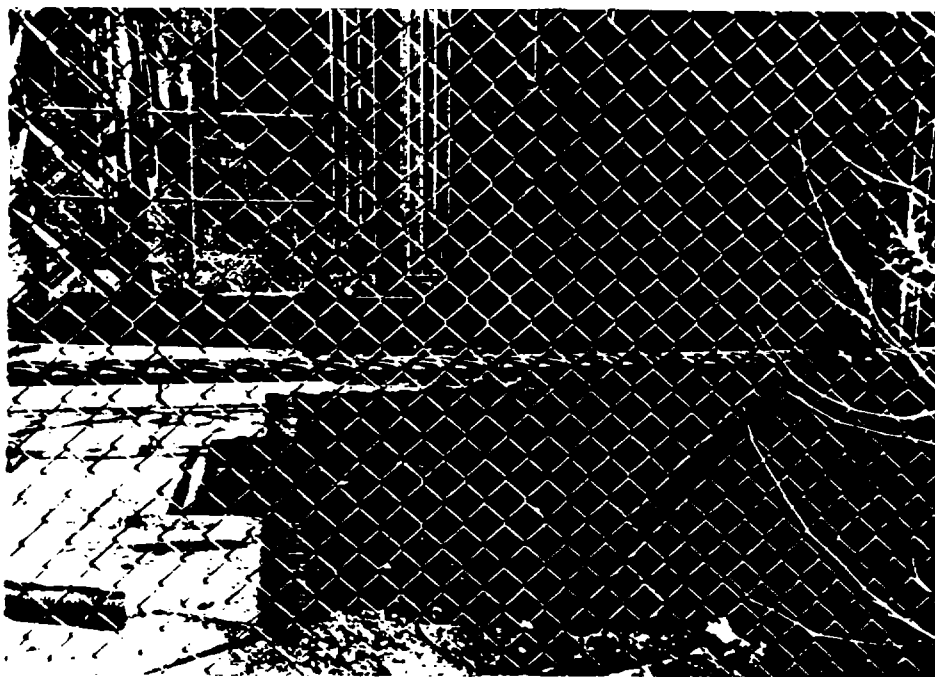
PHOTO 16: DAYTON TIRE AND RUBBER COMPANY, Dayton, OH.
Transformer Area E.

These transformers were also covered with visqueen during the initial response.
(Photo by Bowlus.)
